# Buncefield: Reconciliation of Evidence with Mechanisms of Blast

James Venart  
University of New Brunswick  
Fredericton, NB, Canada

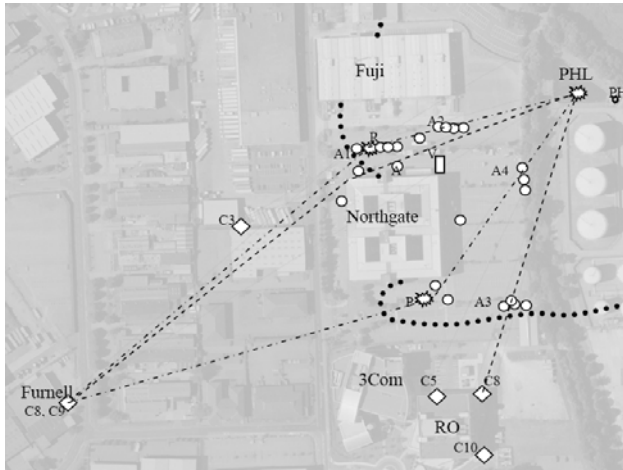
Figure 1 is a photograph of the site. North is to the top of the photograph. There are superimposed labels indicating major buildings; vehicle groups and car parks; CCTV camera locations, their lines of sight; as well as the area of vegetative scorching: indicative of the extent of the vapour cloud. Three Cherry Trees Lane is at the top of the photograph and Buncefield Lane runs N to S just W of the bund enclosing three large storage tanks; the centre one, T912, being the tank which overflowed for nearly 40 minutes allowing over 300 tonnes of winter-grade gasoline at 15 °C to escape, vaporize and mix with air to form the vapour cloud. The resulting cloud overtopped the surrounding bund and dispersed. At no time was the cloud, beyond the bund walls, above the upper flammable limit (UFL). Atmospheric conditions at the time were: no wind, stable conditions, 0°C, 99% relative humidity [8].

Figure 1. Buncefield site plan indicating building, camera and vehicle locations; Cameras  $\diamond$ , Vehicles  $\circ$ , Cloud extent  $\bullet\bullet\bullet\bullet$  [6].

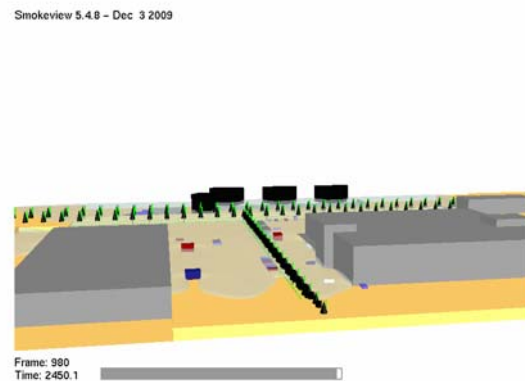
Figure 2 illustrates the dispersion modelling result for the lower flammable limit (LFL) boundary at about 2400s. The LFL boundary of the simulation is seen to conform very closely to the observed regions of vegetative scorching in the western areas between the NG and Fuji and 3-Com buildings illustrated by the cloud's extent; Figure 1. Temporal and geometric comparisons with the CCTV record were reasonable [7].

Figure 2. The NIST FDS5 LFL dispersion model of the Buncefield release at ~2400s. View E between the NG and Fuji buildings from the western edge of the computational domain [7].

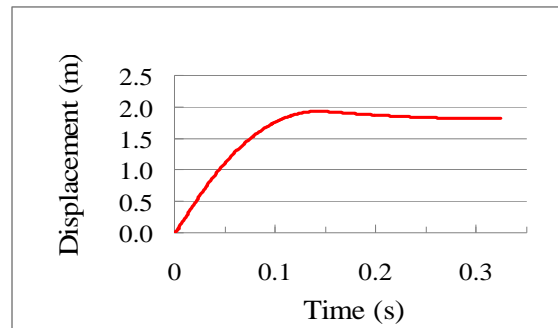
Figure 3. Car displacement for a 5ms positive detonation blast [6].

Figure 3 illustrates the car displacement where it can be clearly seen that the positive phase impulse dominates vehicle motion. Due to the consistency and intensity of vehicle damage over such large and open areas it must be concluded that these aspects of the ‘explosion’ were indeed detonative.

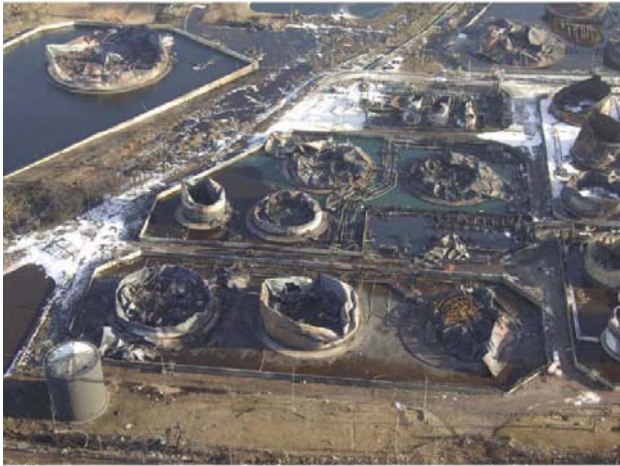
There were several empty, or partially filled, tanks within the tank farm that were damaged in a characteristic fashion – T910 (Bund A); T911, T914 (Bund B); and T6. These failures consisted of the vessels being uniformly circumferentially crushed about mid-height (relative to fill level) into several lobes with plastic wrinkles; the roofs blown off – partially or

completely (T910); and the roof rafters still, for the most part, attached to the outer tank circumference and exposed. For these tanks (~25m diameter) the number of lobes was between 18 and 20. For smaller tanks, for example, T601 to T603; the transfer storage tanks (6m diameter and 9.8m high), the deformations, though still crushing with lobes and wrinkles, these were more numerous and complex; though these too had their roofs torn off. Apparent reductions in volume ranged from between 55 to 60 percent for T601 and T910 respectively. This type of deformation is characteristic of what is called elastic dynamic pulse buckling and results from a suddenly applied uniform radial impulse [16]. Figure 4 is the aerial overview of the tank arrangements within the bunds taken from the W.

Simple analysis [7] concluded that tanks T910 and T601 were crushed by elastic impulse pulse buckling with average blast loading overpressures of between 0.38 and 0.85MPa.

Figure 4: Aerial view to East of Bund A and its tanks. Tank T912 is in the centre foreground, T910, which was empty at the time of the incident, is to the right of T912; T601 to T603 are at the top of the photograph. [1].

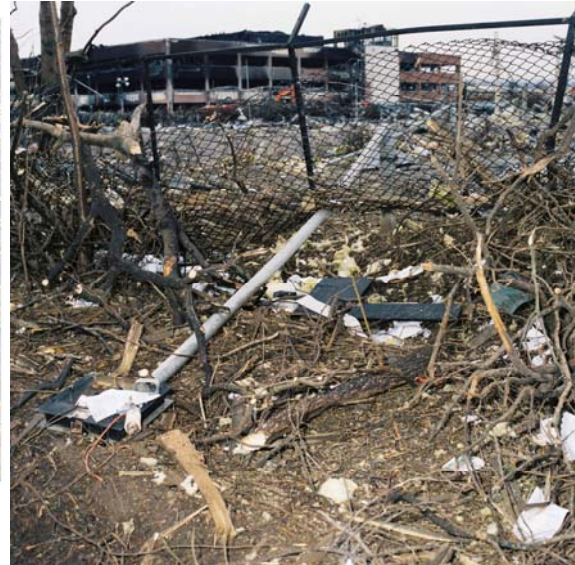
Reference [6], in their analyses of CCTV records from the RO and Furnel Buildings noted that the Buncefield event was very complex consisting of two major deflagrative and two, near simultaneous, detonative events. Reference [1] and others, however, concluded that the explosion resulted from flame acceleration up Three Cherry Tree Lane to DDT and then W into the Fuji and NG car parks and down Buncefield Lane; i.e., a continuously developing event. Directional evidence in the form the deformation and snapping off of lampposts, fence posts, CCTV masts, trees, etc. and *assumed* representative of the negative phase pressure loading was used in support of this conclusion. There were, however, several inconsistencies in the observed data for the lampposts. In particular most lampposts in the car park E of the NG Building appeared to be vertical and not deformed – though many had been abraded by dust and grit on particular sides at their bases. This observation, based upon the assumption that the abrasion was the result of a negative pressure phase of the explosion, was used to infer blast direction. On the other hand lampposts, fence posts, and other indicators (e.g. trees) at the S edge of the Fuji car park were badly deformed, bent and some collapsed or snapped/fractured most pointing E or NE – some confusingly so. For example Figure 5 shows a fractured lamppost felled to the NE (with another to the W behind it felled to the E). Here the perimeter fence between the Fuji car park and Buncefield Lane appears blown overtop of the already felled lamppost. In an attempt to understand this and other behaviour, several lamppost FE (Finite Element) models were constructed and subjected to blast loadings using the ideal blast model taken from [6]. Lamp posts subjected to such loadings were snapped off by the applied positive phase of the blast in much the same way as seen in the figure [7].

Figure 5: Fuji carpark lampposts: Lamppost in foreground has been hit by blast, snapped and then felled NE. The Fuji carpark Buncefield perimeter fence has next been blown down, up over the felled lamppost base, and then dragged over the fallen pole. A similar pole in the background has also been snapped and blown down to the E.
