Explosion Damage in the Unit 4 Reactor Building of Fukushima Daiichi Nuclear Power Plant

Takashi Tsuruda
Akita Prefectural University
Yurihonjo, Akita, Japan

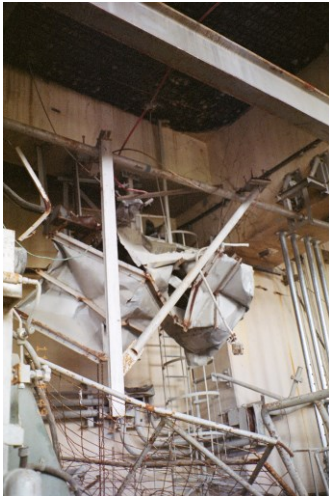
Figure 1 shows the north-west corner of the fourth floor. The ceiling panels are totally lost and panel supports are seen in this figure. The surface of ceiling concert is lost and steel mesh, which was embedded in concert, is exposed. The explosion blew the north wall and a large opening is formed. The remaining of the duct shows compression from the outside. This deformation indicates that the pressure on the fourth floor was much higher than the internal pressure of the duct. Connecting boxes of wirings are also compressed from outside. A rapid pressure buildup occurred in this area.

Figure 1 Damaged Duct

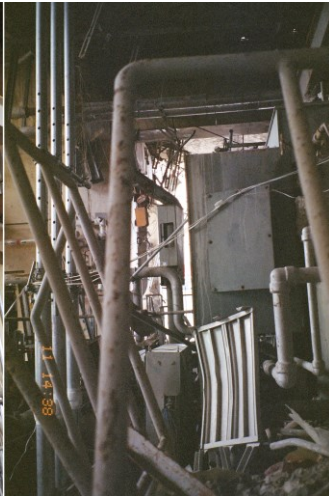
Figure 2 shows part of an MG set. A rectangular case in the center is slightly covered with soot. The north side opening is seen behind the case. The upper rim of the opening is covered with soot. Fragments are piled up high on the floor. Figure 3 shows blackened thermal insulators on the floor near the MG set. Leaked oil seemed to soak into thermal insulators and ignite by some ignition source.

Figure 2 MG set

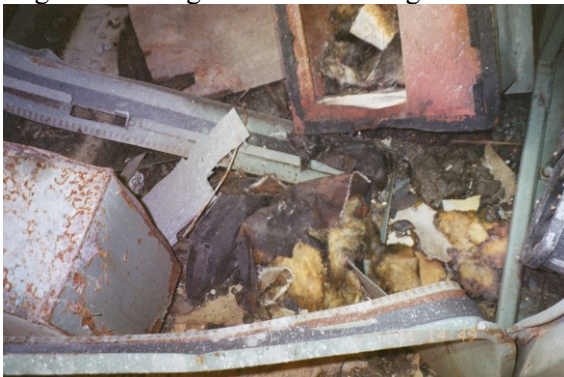
Figure 3 Black colored insulators near an MG set

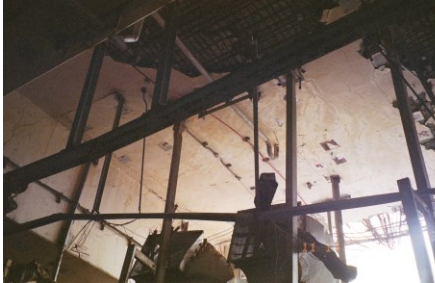
Figures 4 and 5 show ceiling. Part of ceiling surface concert is lost in fig. 4. Cracks run along the ceiling surface concert in fig. 5. Two ducts remain in the lower part of fig. 4.

Figure 4 Ceiling near an opening

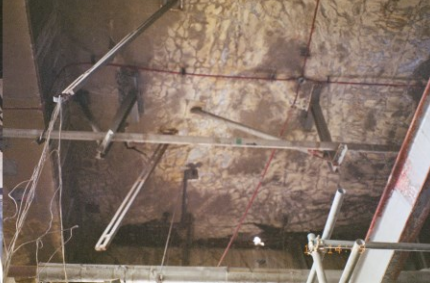
Figure 5 Ceiling near an MG set

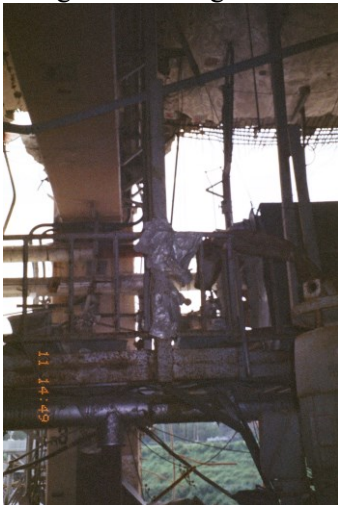
Figure 6 shows the west side opening. A metal cover of thermal insulator was caught in a pole at the center of this figure. The direction of gas flow during the explosion was west at this point.

Figure 6 West wall opening

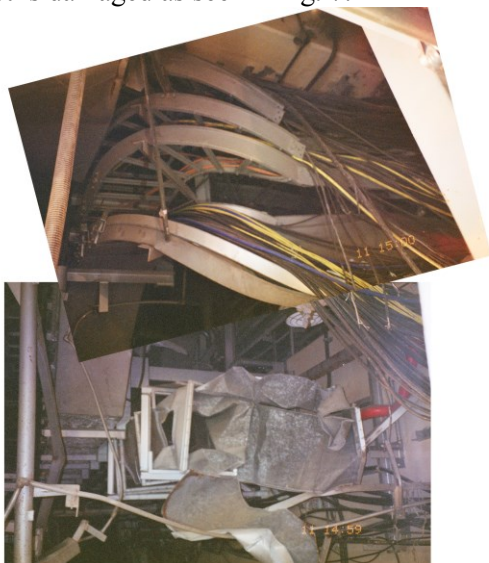
Figure 7 shows a composite photograph of duct and cable rack on the first floor of the unit 4 reactor building. This is supply duct and damage is limited at the opening. The cable rack above the supply duct is damaged as seen in fig. 7.

Figure 7 Duct (lower) and cable rack (upper) damage

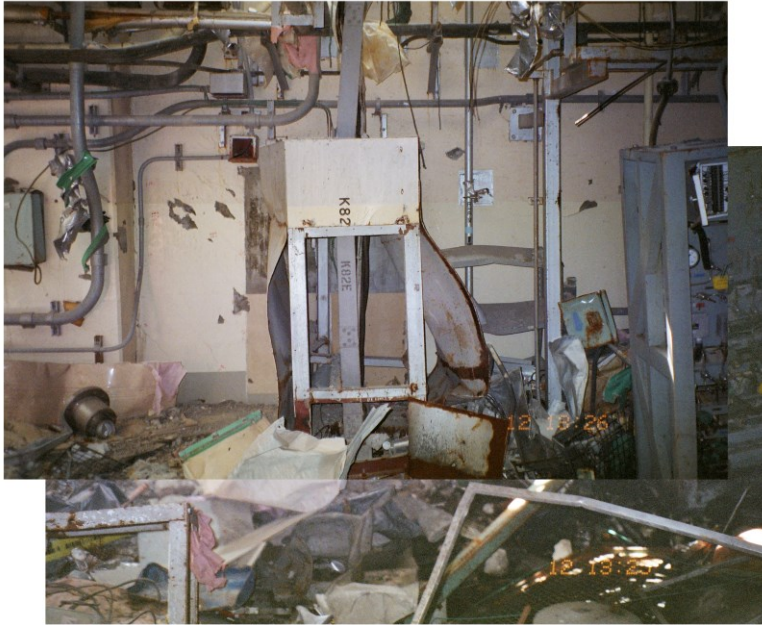
Figure 8 shows a composite photograph of K82E box on the third floor. Plastic sheets are seen upper part of the figure. Green fragments are on the left side of the picture. An exploded box K82E is at the center of the picture. A light green color box right of the exploded box is compressed slightly.

Figure 8 Front view of K82E

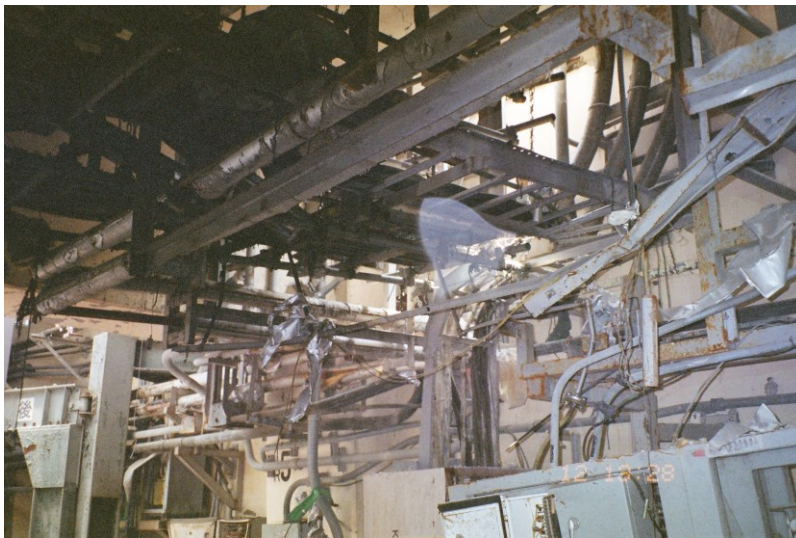
Figure 9 shows side view of the area in figure 8. A cable rack locates in the exploded box K82E. It seems that the gas flow from the upper floor conveyed fragments and gas into this section.

Figure 9 Side view of K82E

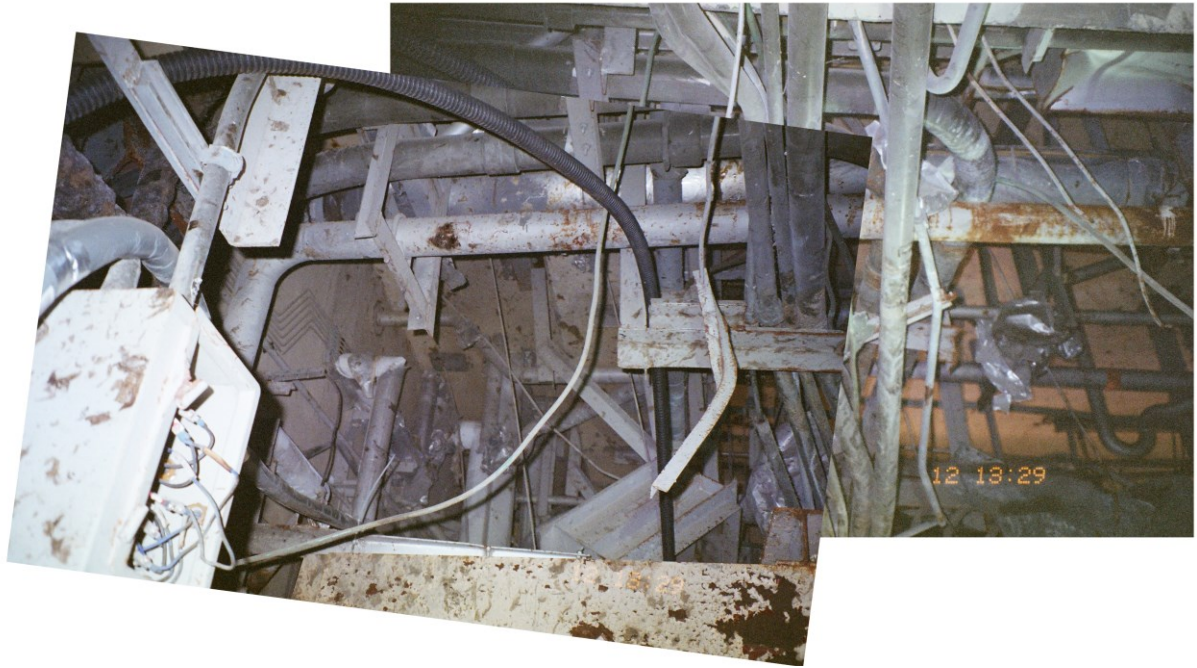
Figure 10 shows a composite photograph of fragments on pipes. Induced flow conveyed these fragments all over the floor. Figure 11 shows fragments on cable rack. Sharp fragments could damage coated cables. If a fire occurs after a gas explosion like unit 4 case, the surface coat damaged by sharp fragments might not withstand the designed heat stress of fire. Figure 12 shows heat damages on plastic materials. Green colored large fragment and small transparent one were caught in a red frame at the center of this figure. These plastic materials experienced a high temperature environment.

Figure 10 Fragments on pipes

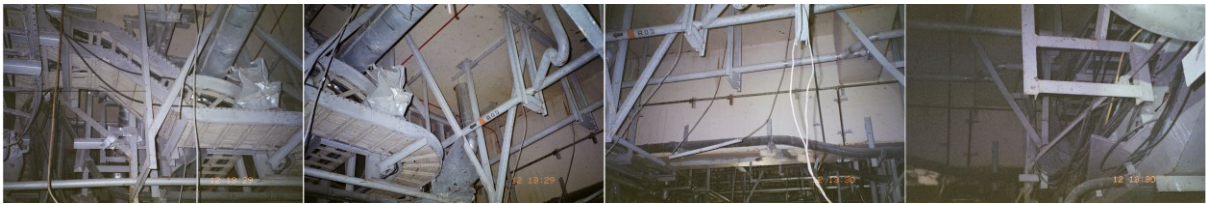
Figure 11 Fragments on cable rack

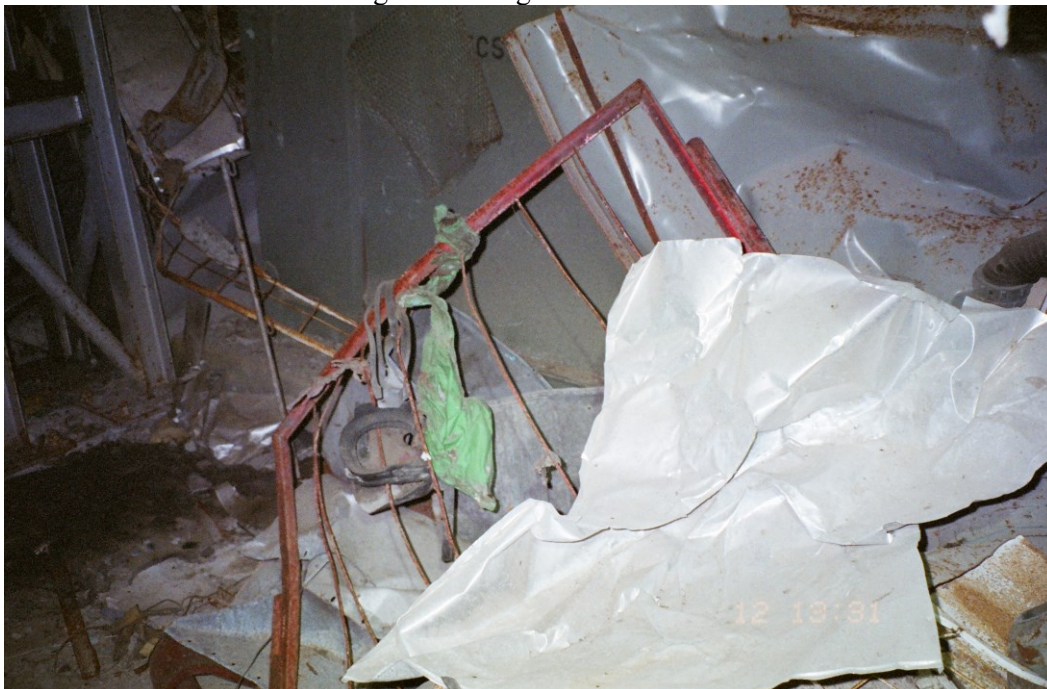
Figure 12 Heat damage on plastic materials
