# A Re-evaluation of Lamppost Deflection Data in the Buncefield Explosion

J. E. S. Venart, R. J. Rogers  
University of New Brunswick  
Fredericton, NB, Canada

This paper presents finite element deformation studies of two types of lampposts found at Buncefield. The analyses use CJ blast loading based upon the posts being assumed to have been within the combustible cloud under a variety of blast and estimated negative wind conditions. The analyses and comparison to site photographs reveal discrepancies in the reported and the accepted, till now, assumed blast directions. These results, if true, suggest the necessity for a reevaluation of assumed ignition positions and blast formations in this event.

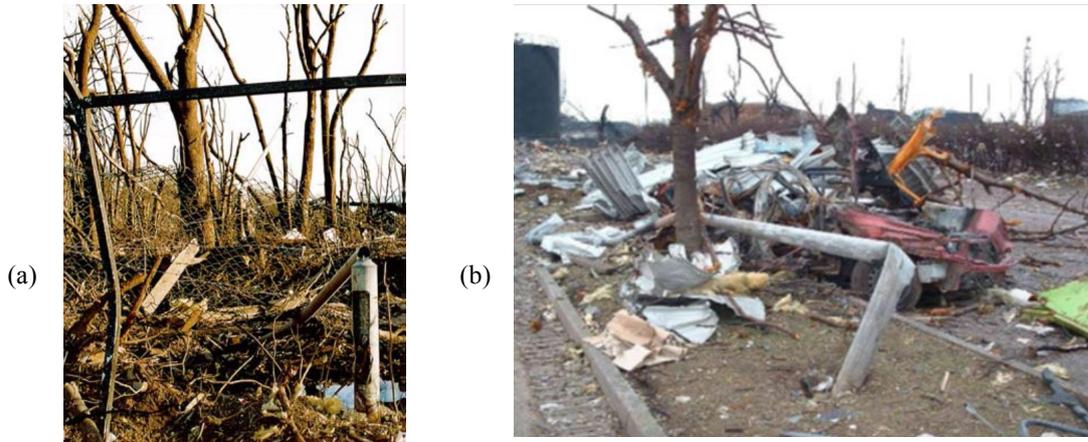
There were, however, many inconsistencies in the observed data for the lampposts and vehicles. Most lampposts in the car park directly E of the NG Building appeared to be vertical and not deformed – though many had been abraded by dust and grit on their bases. However many lampposts were snapped off or buckled most, with bases and poles pointing east or north east – some confusingly so, Figures 1(a, b).

For example Figure 1(a) shows a fractured lamppost felled to the north east (with another to the west behind it in the Fuji car park felled to the east). Here the western Buncefield Lane perimeter fence between the Fuji car park and Buncefield Lane appears to have been displaced upwards before the post was felled by blast. This blast, speculated to originate from the N side of shrubs/fencing must have taken place after an updraft, possibly caused by a rising fireball from ignition of the richer fuel in the lagoon [2], allowing the fence to drop down over top of the now already blast felled lamppost.

In the case of the Type B lamppost model, the tapered pole with side cut-out, the loading response was sensitive to direction and positioning of both the cut-out and the positioning of the offset lamp housing relative to the assumed CJ blast direction. In order to replicate the collapse mode noted in Figure 1(b), the pole had to be buried in a simulated surrounding soil. The case with a S exposure of the cut-out and N extension of the lamp arm under a CJ blast originating from the W replicated quite well the observed failure for the lamppost located near the SE corner of the Fuji building, Figure 1(b) and Figure 3.

Figure 1. (a) Type A light pole on the W side of Buncefield Lane opposite the eastern edge of the Fuji Building indicating a felled E direction. The fence appears overtop the already fallen light-pole [9]. (b) View from the W of lamp pole Type B very near the S-E corner of the Fuji Building. The lamppost has been hit by blast, buckled and felled E [9].

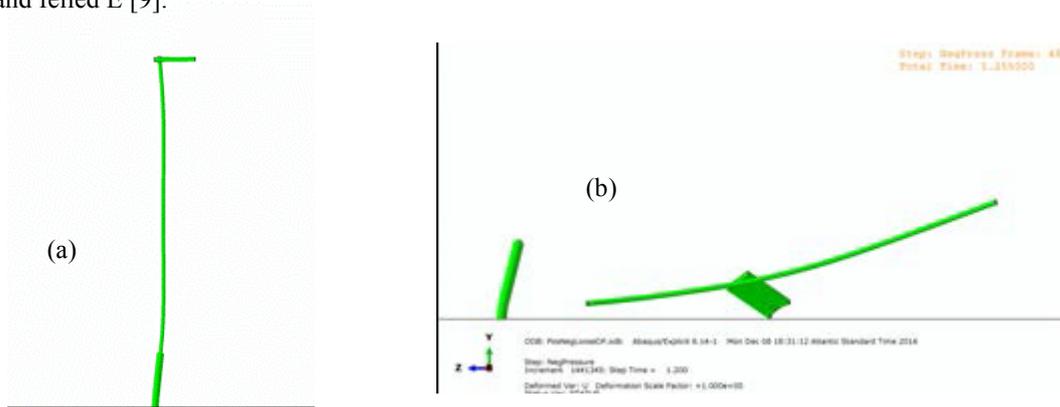
Figure 2(a) shows the slight deformation after the positive load phase and Figure 2(b) shows the configuration at  $t=1.2$ s. The simulated system is not quite at rest and further vertical settling will occur. The base post shows a permanent lean in the direction of the positive

pressure. The pole snapped at the base-pole connection and lamp box landed to the east of the base post, consistent with the actual lamppost shown in Figure 1(a).

Figure 2. Type A lamppost: (a) At end of positive phase loading,  $t=0.005s$ . (b) At  $t=1.2s$ .

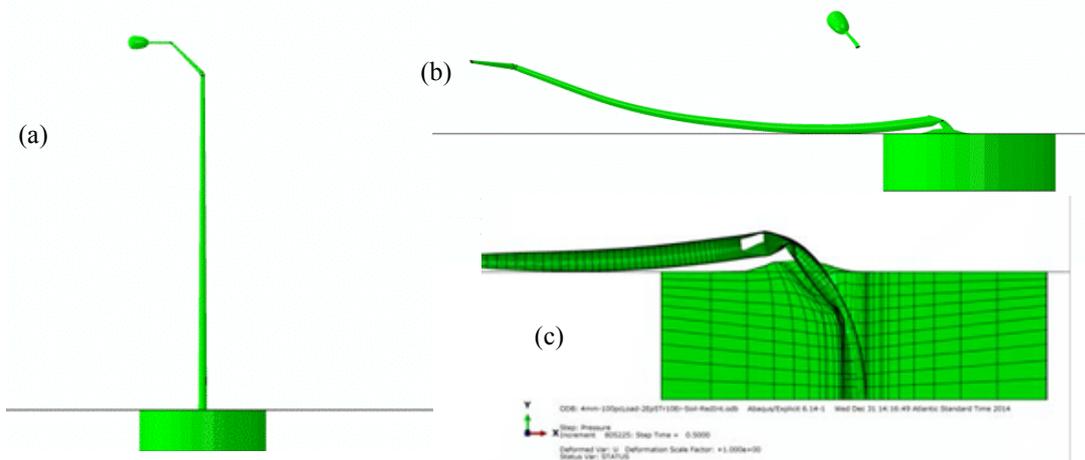
The simulation results for the Type B lamppost for the 100 percent loading are shown in Figure 3. Reduced loading at 75 percent loads, for both positive and negative phases, left the pole only bent; 75 percent positive loading and 100 percent negative loading caused the pole to bend to the E during the positive and negative loadings, but finally buckle and fall to the W; however its base was still left tilted E due to the original positive phase load.

Figure 3. Type B lamppost (a) Initial condition. (b) End of simulation for 100 % blast and negative phase loading. Blast direction from right to left. (c) Close up of buckled, 100% loaded Type B lamppost; blast direction from right to left. Note soil deformation and compare to Figure 1(b).
